The El Salvador earthquakes of January and February 2001: context, characteristics and implications for seismic risk

Keywords: El Salvador; Earthquakes; Strong motion; Landslides; Seismic risk; Vulnerability

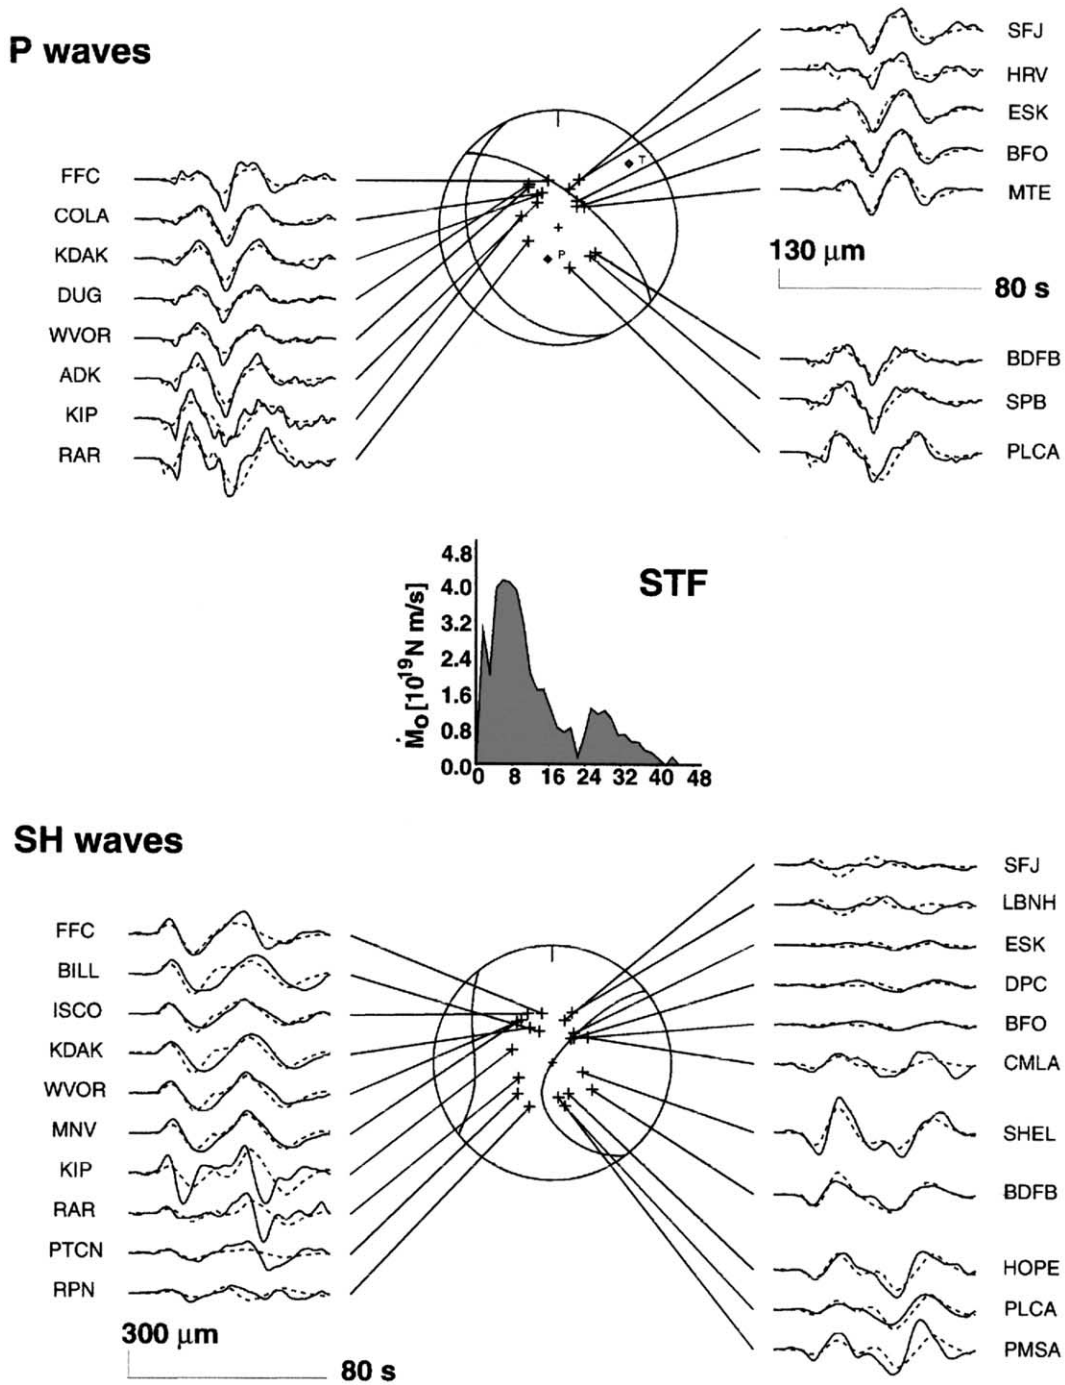
Fig. 4. Analysis of broadband body waves for the 13 January 2001 earthquake. Top: observed P-wave seismograms (solid lines) are in general fitted well by synthetics (dashed lines) computed for a point source model with focal mechanism and source time function shown. Bottom: as above but for SH waves.

Fig. 4 shows body-waveform inversion results for the earthquake of 13 January. For this event, P waves were relatively well fitted by our simple point source model. For P- and S-waves the first arrivals were not very well modelled because the S-waves—which are much stronger—dominate the inversion. The strong SH arrivals force the source time function of the earthquake to start with a very strong impulse. The peak appears to be much weaker for P-waves. The depth we found was 50 km. The more vertical fault plane was well constrained by the azimuthal coverage. The source time function can be divided into two sub-events: the first one had higher amplitude and a duration of 22 s; the second sub-event occurred during 24 seconds. The seismic moment was 5.54×10^{20} N m; it is difficult to observe any directivity effect. However, if we compare signals from LBNH and KIP stations with their synthetics (which were modelled with a point source), we observe a possible directivity effect. If we assume that the fault plane is the sub-vertical one, as is commonly observed for intraplate events, there could be an upward rupture propagation (Fig. 4); more data is required in order to constrain this directivity. The M_w 7.7 earthquake of 13 January 2001 was an intermediate depth earthquake that occurred inside the down-going Cocos plate; its tension axis was sub-parallel to the dip direction of the descending slab.

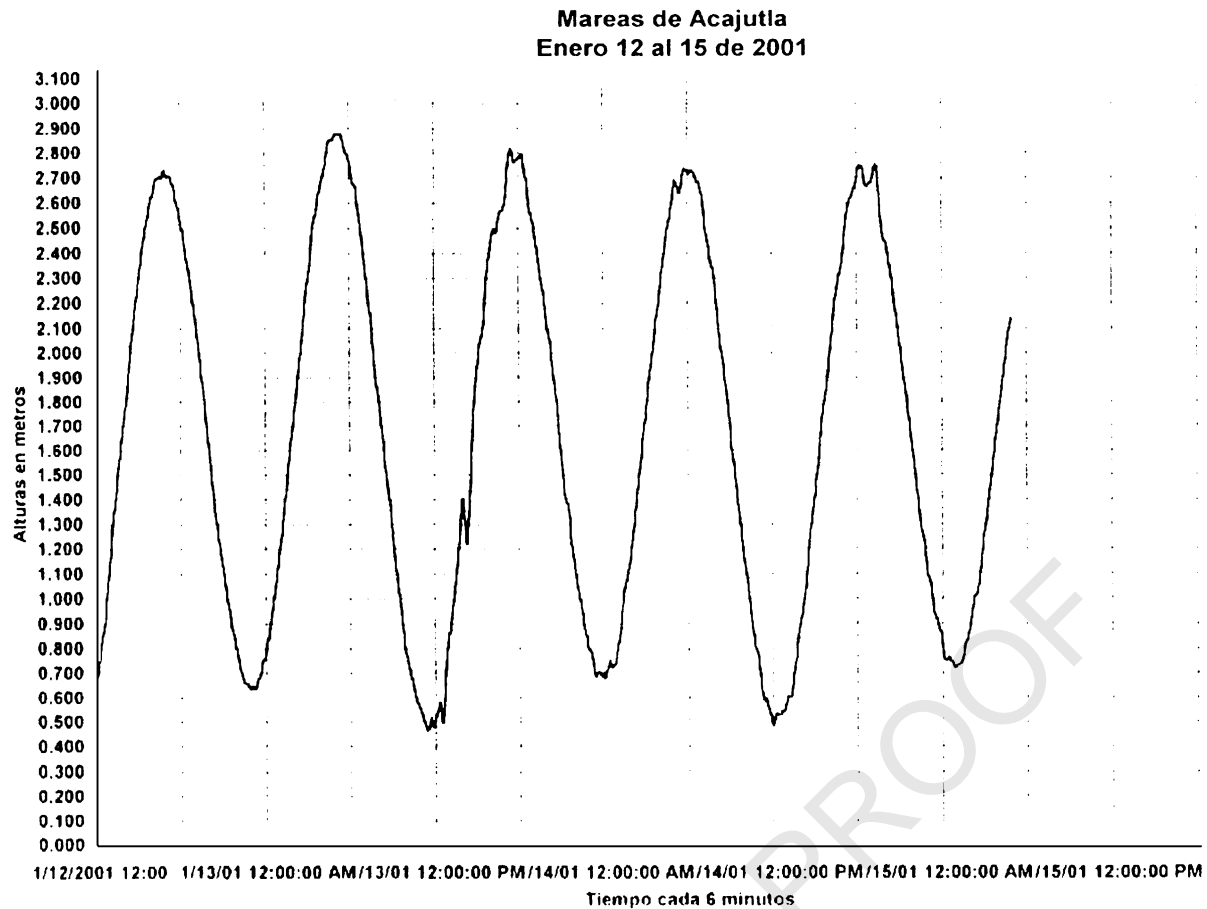
Fig. 5. Tide gauge record from the port of La Libertad showing height above mean sea level (metres) from 12 to 15 January 2001.

In view of the agreement that the focal depth was of the order of 50–60 km, the earthquake would not have been expected to generate tsunami, even though there have been reports of a minor seismic sea wave [44]. Fig. 5 shows a tide gauge record from the port of Acajutla in which it can be seen that no tsunami occurred; the fluctuation in sea level at the time of the earthquake was comparable with ambient noise levels,

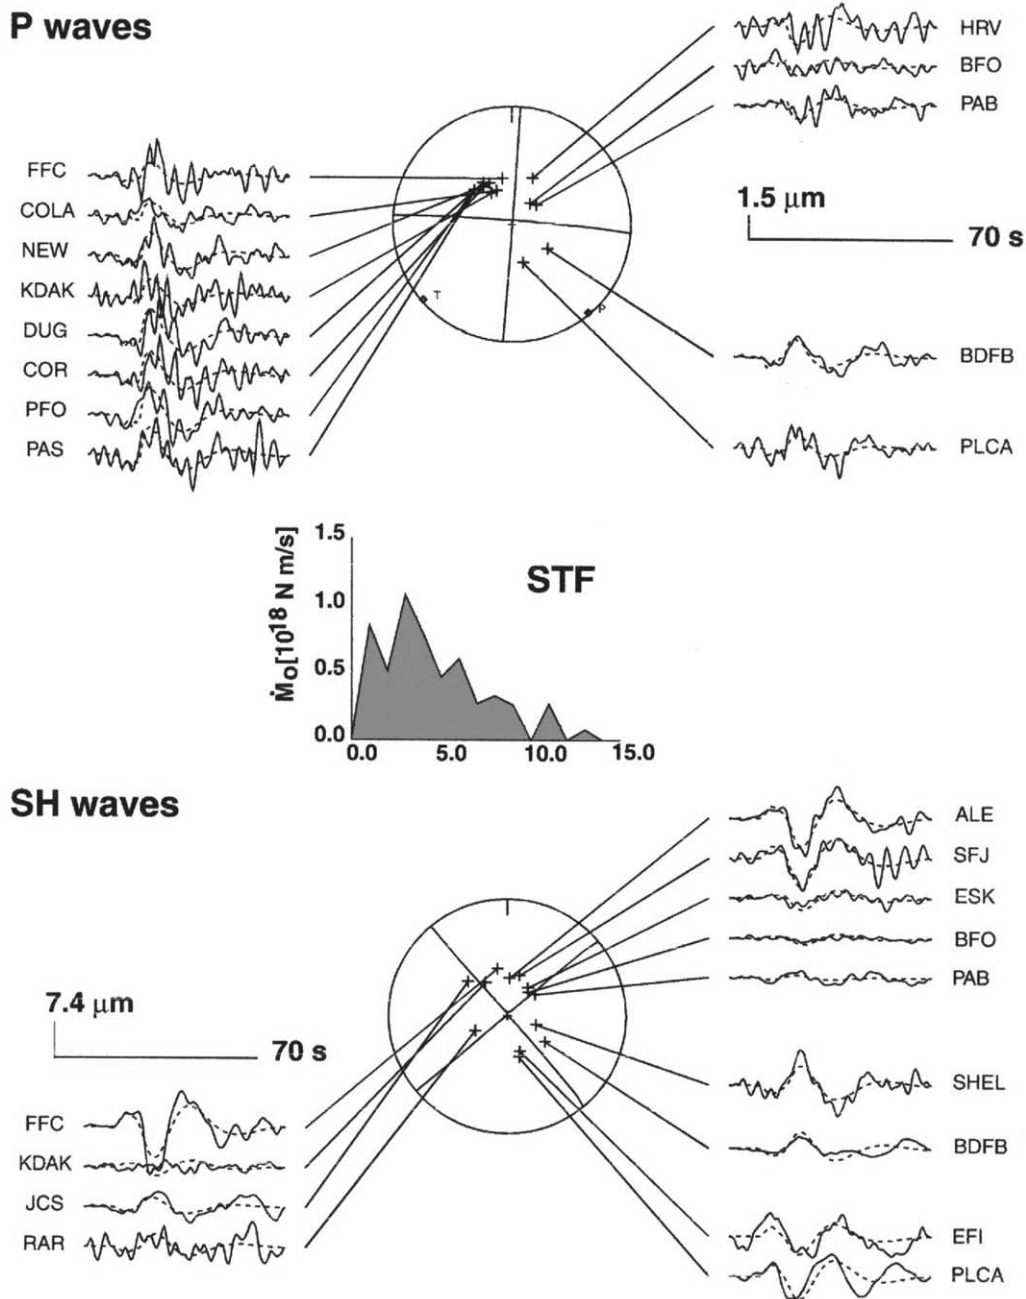
Fig. 6. Analysis of body waves for the 13 February 2001 earthquake. As for Fig. 4 except that only P-waves are considered.

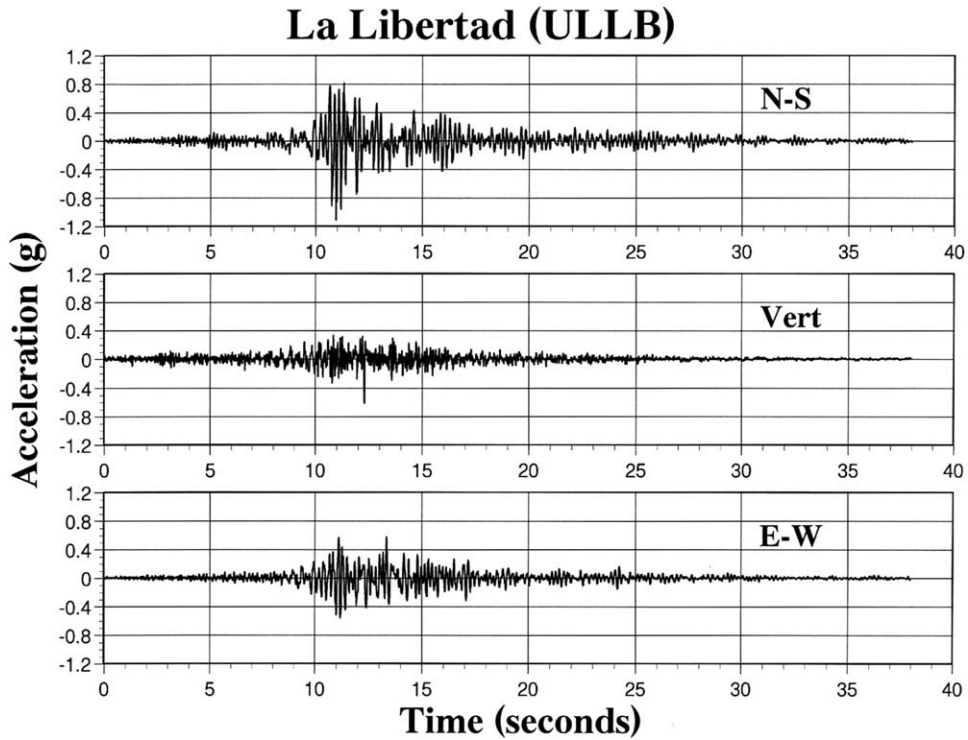
Fig. 9. Accelerogram recorded at La Libertad during 13 January 2001 earthquake.

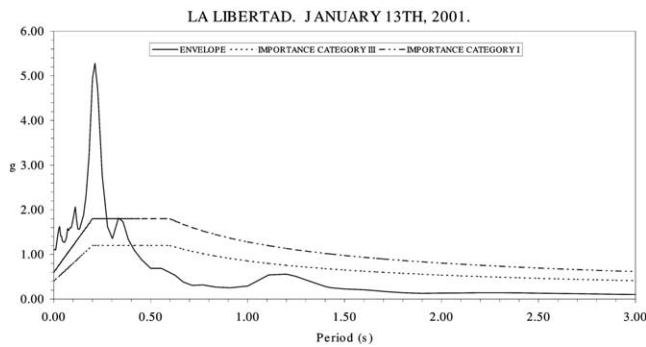
Fig. 12. Envelope of horizontal acceleration spectra from the 13 January recording at La Libertad compared with the elastic spectra from the 1994 design code for soil class S3 and importance categories I and III.

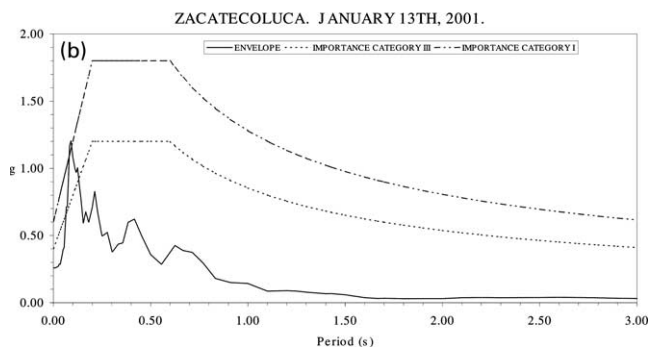
Fig. 13. (a) Envelope of horizontal acceleration spectra from the 13 February recording at Zacatecoluca compared with the elastic spectra from the 1994 design code for soil class S3 and importance categories I and III. (b) Envelope of horizontal acceleration spectra from the 13 January recording at Zacatecoluca compared with the elastic spectra from the 1994 design code for soil class S3 and importance categories I and III.

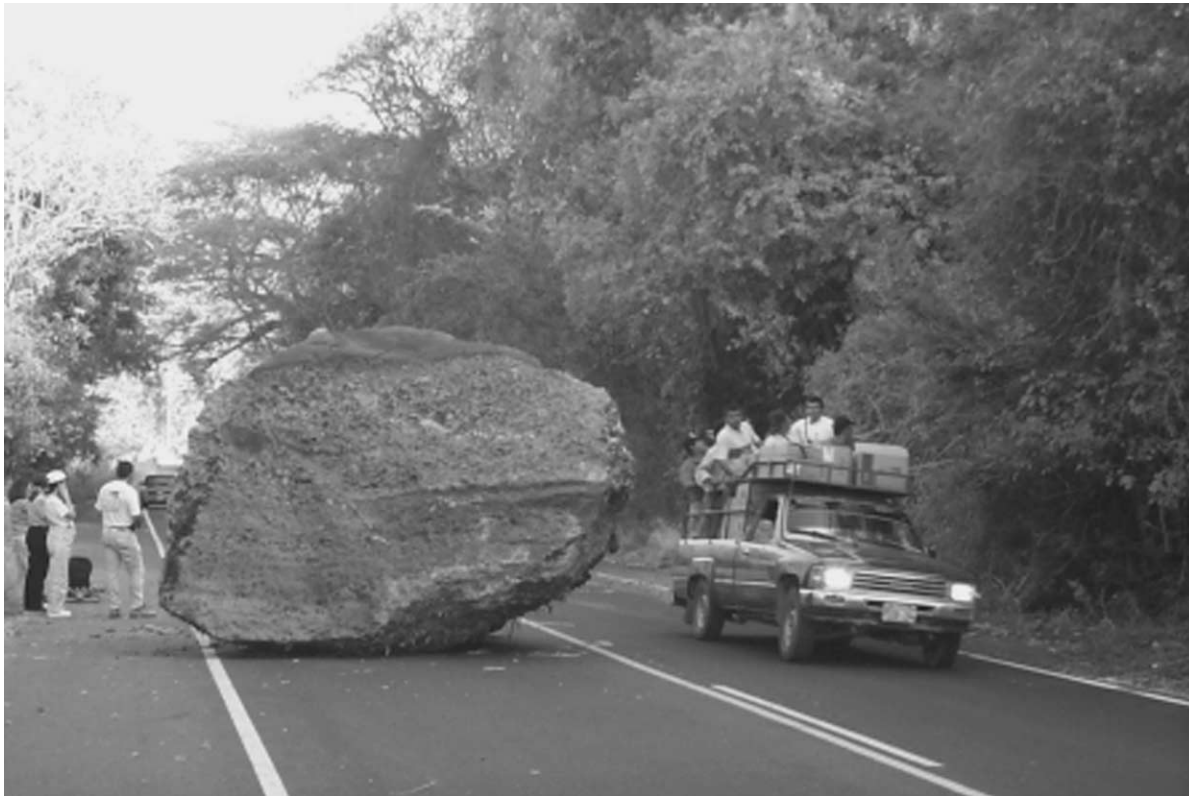
Fig. 14. Single block fall, triggered by an aftershock of the 13 January earthquake, on the coastal motorway near La Libertad.

area and ranged from single block falls (some of which were up to 3 m in diameter, Fig. 14) to the collapse of slopes cut in pyroclastic ashfall deposits, which exist as a result of weak cementation and high negative pore pressure [28,68]. Such failures were largely independent of lithology, but occurred only on steep slopes. Individual block falls were more common in the rocks of the Bálamo Formation because of the prevalence of persistent discontinuities in the form of bedding and cooling joints. Highly altered layers of volcanic rock also acted as aquitards.

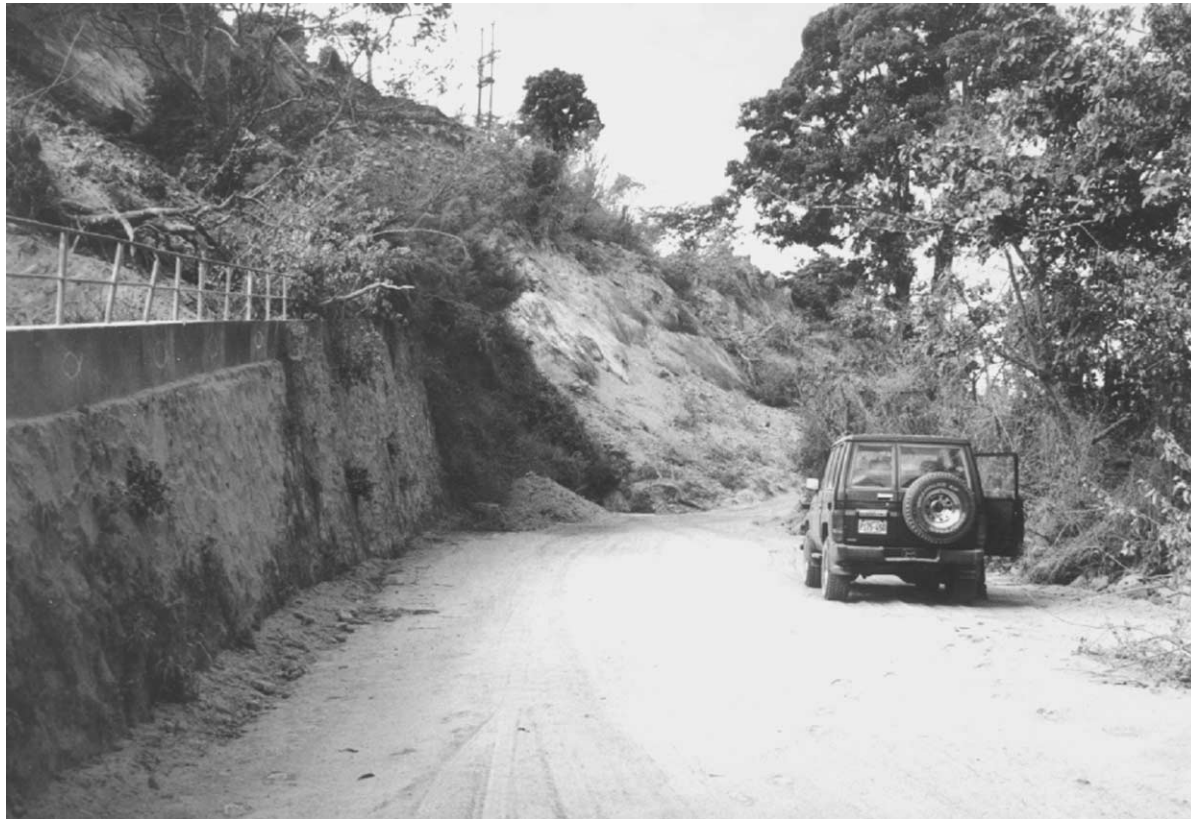
The occurrence of rock and debris falls in the *tierra blanca* affected an extensive area around the Comasagua Road on the Bálamo Ridge. Here the steep slopes which were formed as part of the road construction and also by quarrying failed in spectacular manner giving rise to an extensive area of slope instability which extended from the landslide at Las Barrioleras to the Jayaque–Comasagua Junction (Fig. 15) and in Comasagua itself (Fig. 16). This formed a classic shattered ridge. In many cases, it was impossible to tell where one landslide ended and another began.

Fig. 15. Debris fall from the Tierra Blanca near Comasagua.

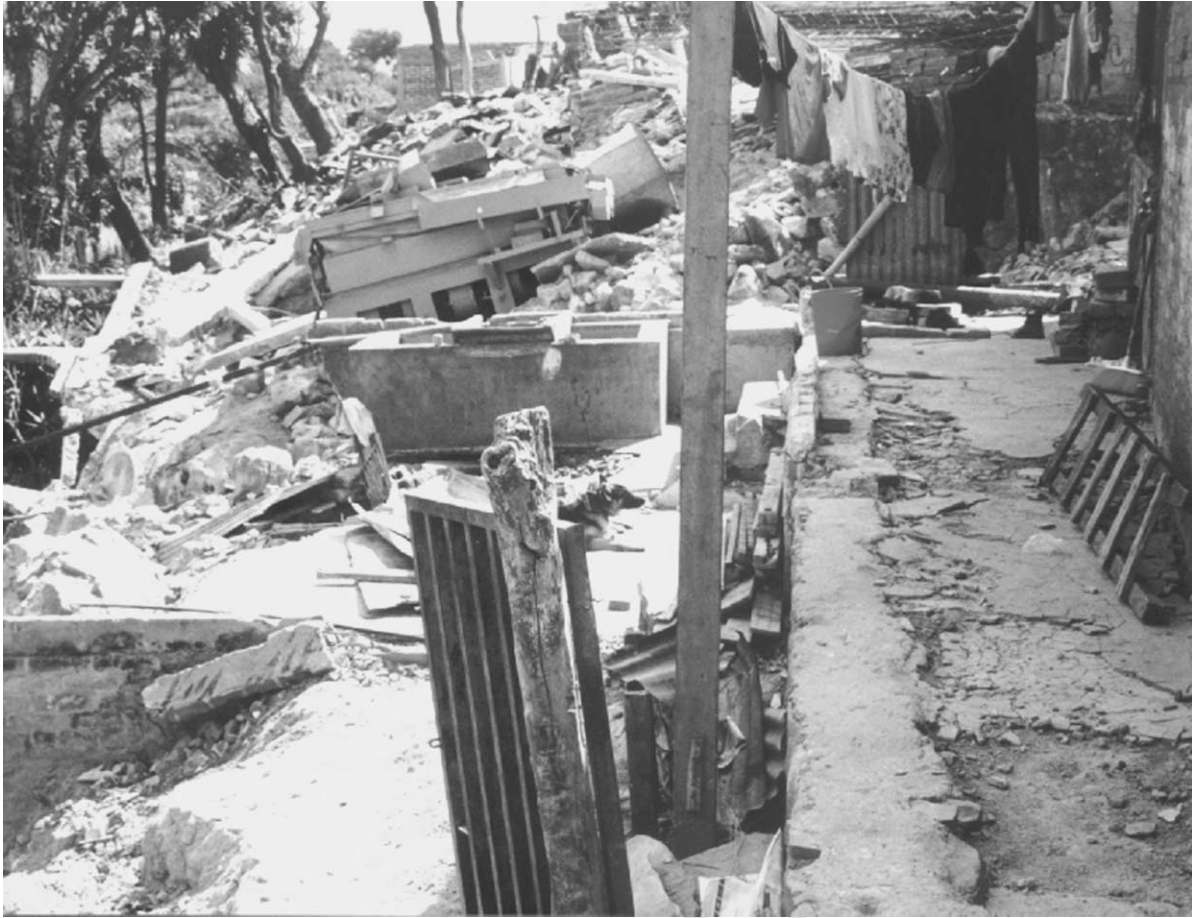
Fig. 16. Landslide damage in Comasagua.

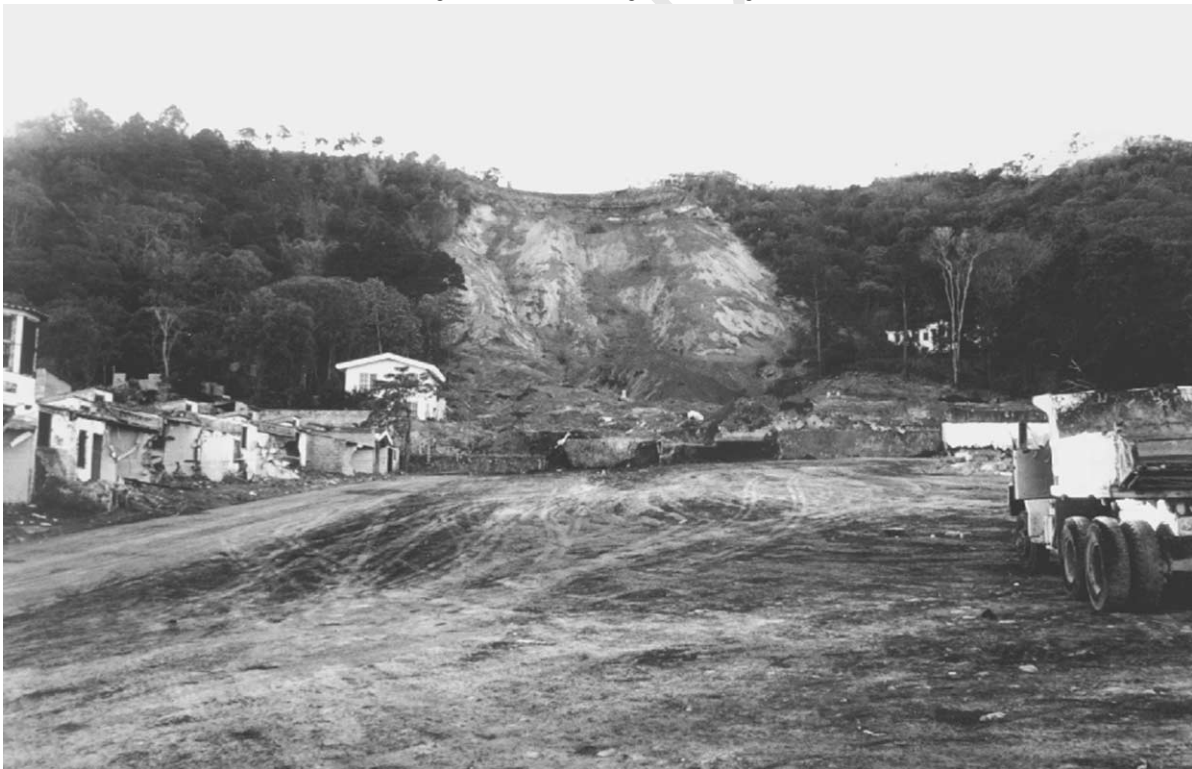
Fig. 17. The Las Colinas landslide, Santa Tecla.

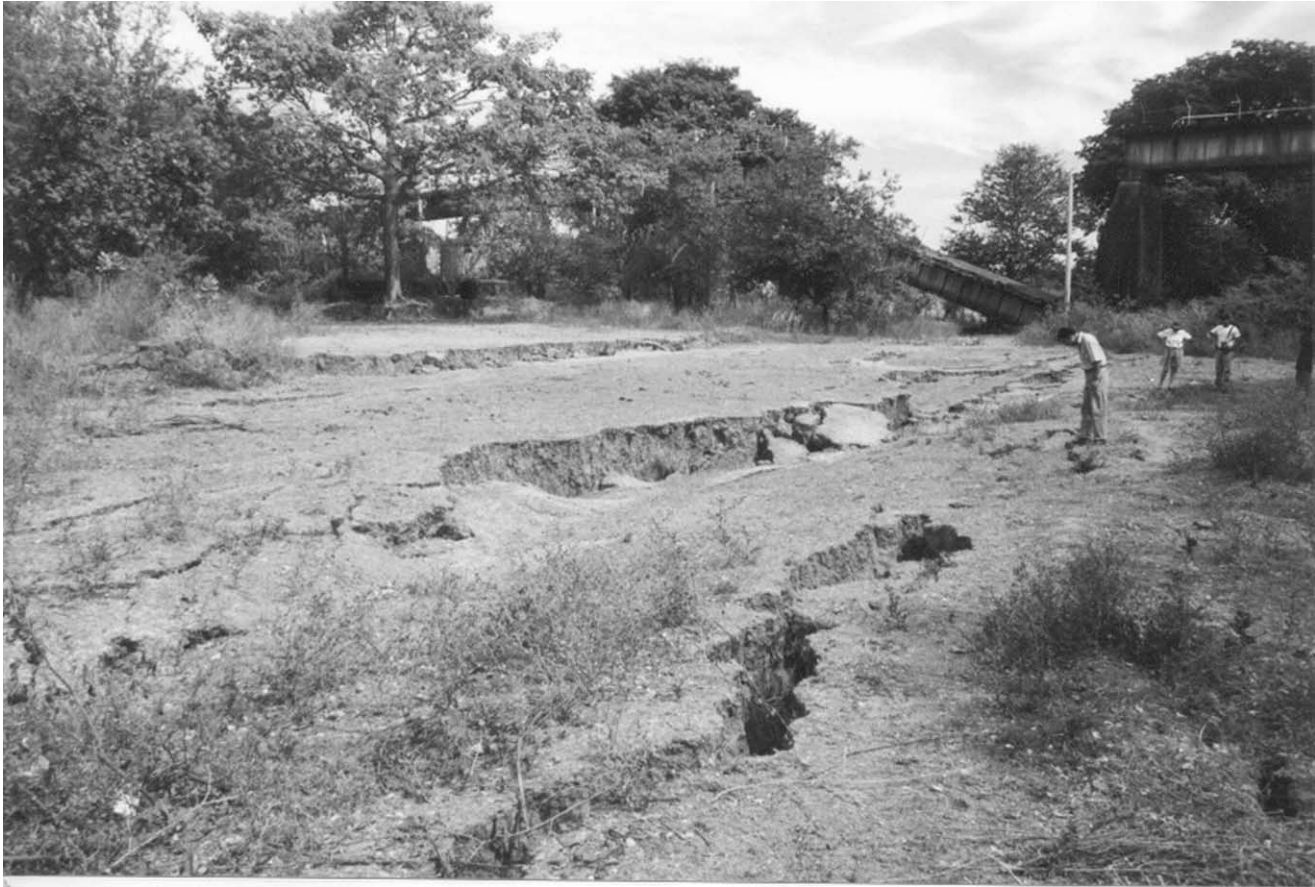
Fig. 19. Lateral spreading on river bank at San Nicolas Lempa.

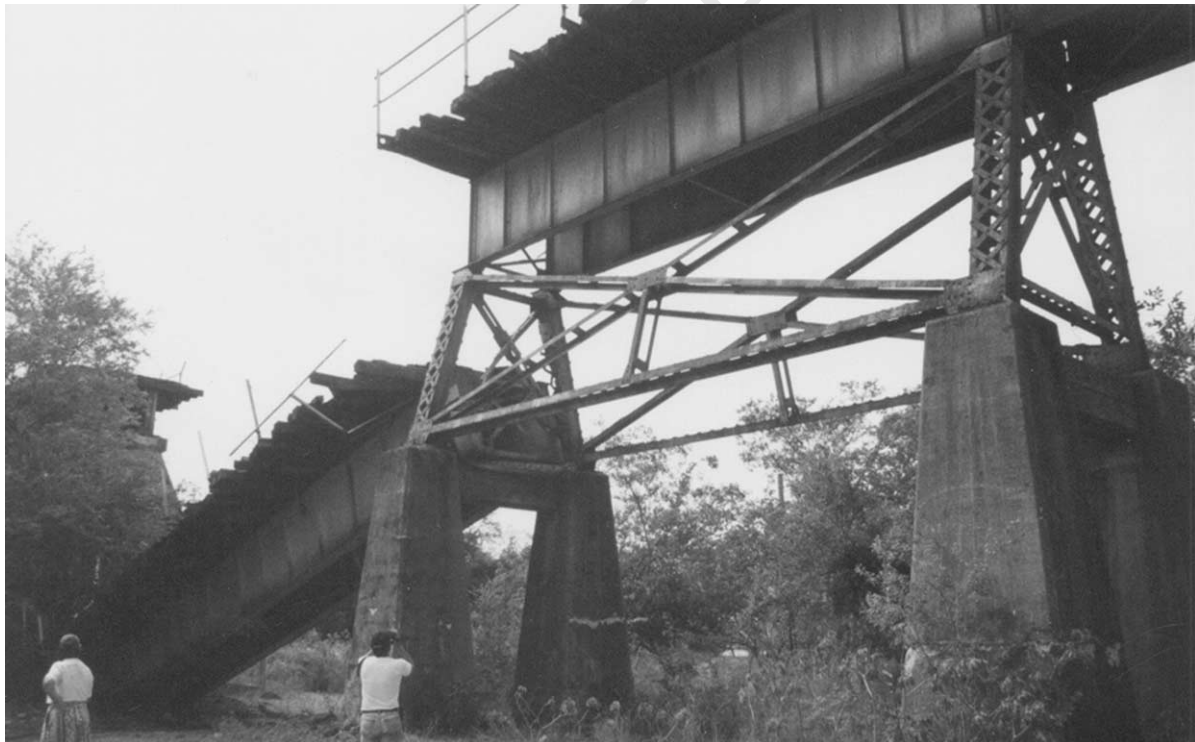
Fig. 20. Collapse of railway bridge due to lateral spreading on banks of the Lempa River.

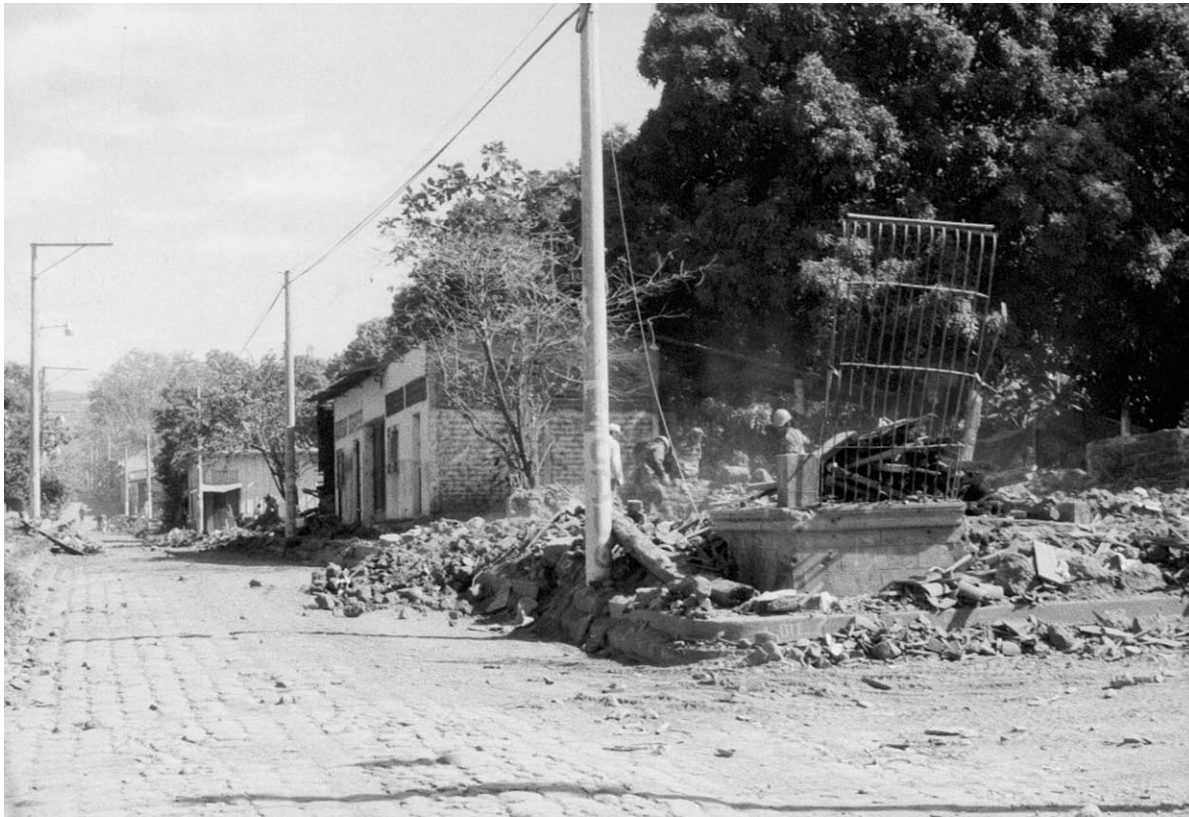
Fig. 21. Collapsed *adobe* house in San Agustín, of which only the door remains standing after the 13 January earthquake; behind are houses of *mixto* and *lamina*, which have survived the earthquake.

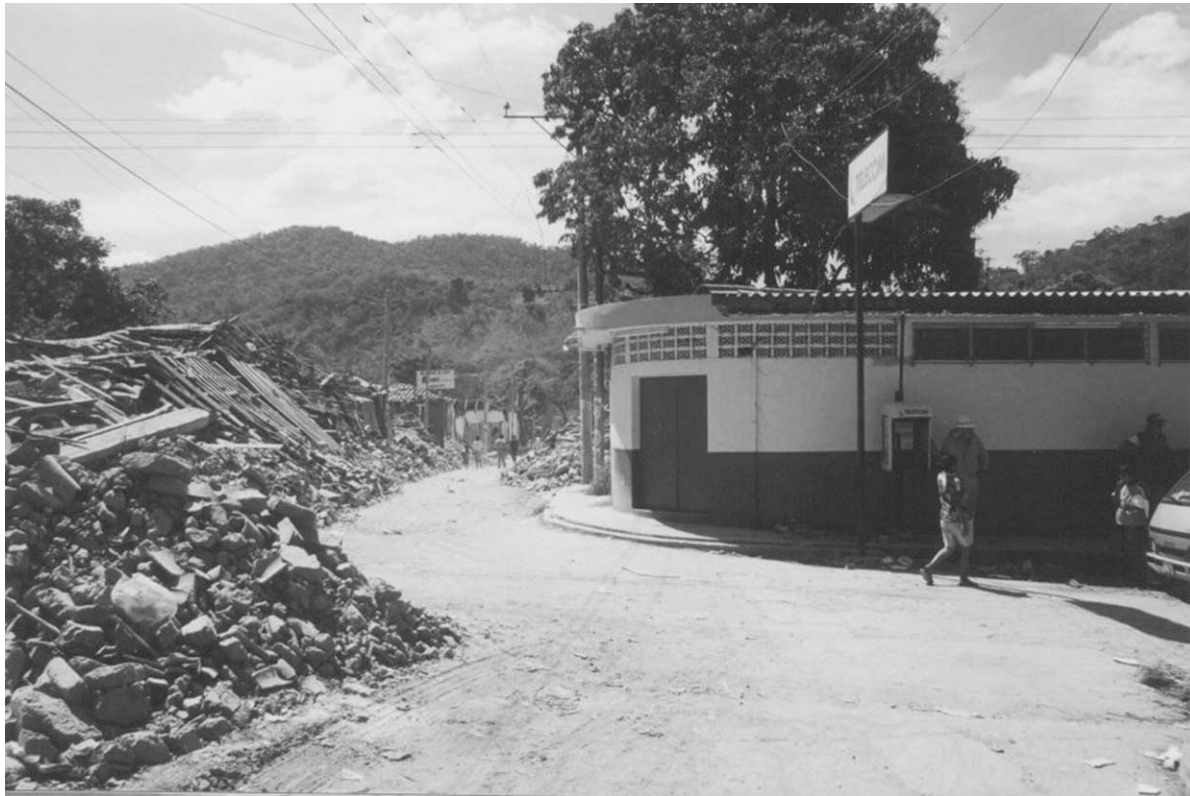
Fig. 22. Guadalupe following the 13 February earthquake, contrasting total collapse of *adobe* houses with the almost undamaged state of the reinforced masonry building to the right.

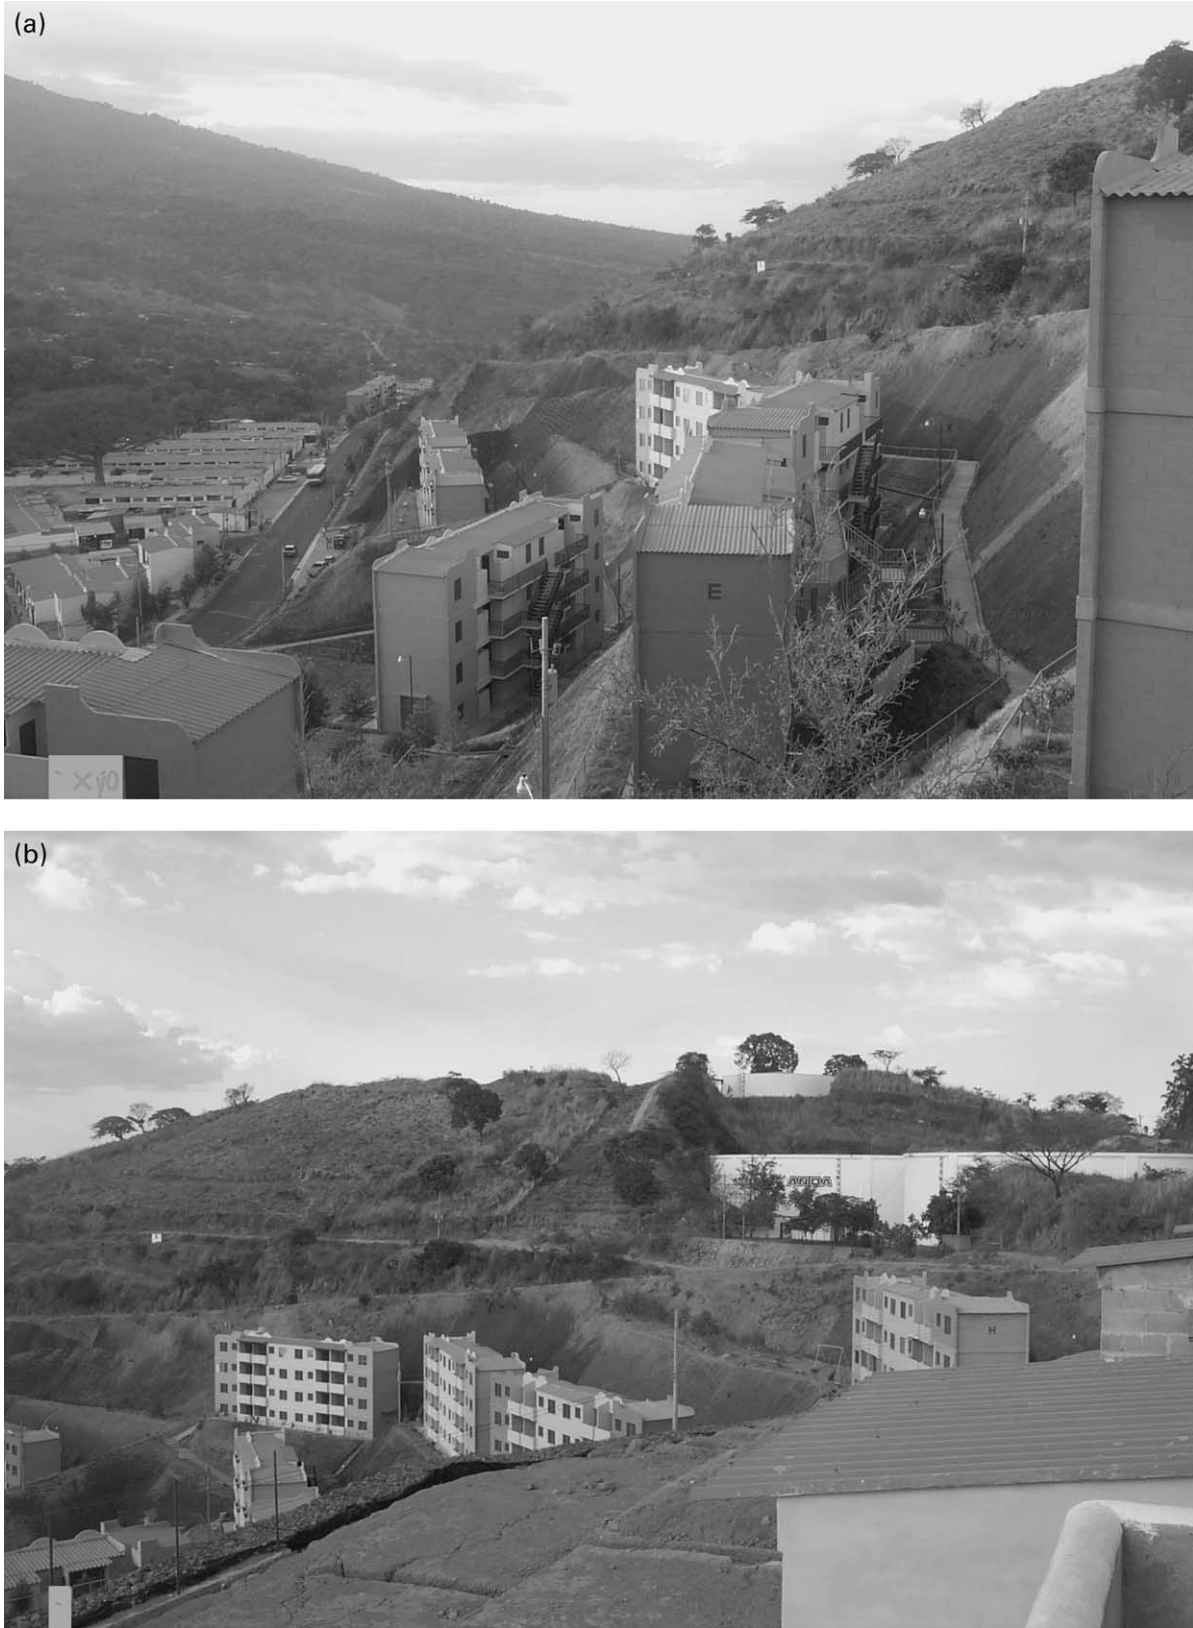
Fig. 23. Santísima Trinidad residential area north of San Salvador built on terraces along a steep slope (a) above which are three large water tanks (b).
